CHAMBERLIN Roofing & Waterproofing

BAMC's Skylight Resuscitated

SPRING 2022

The Case of the Delaminating **Exterior** Paint

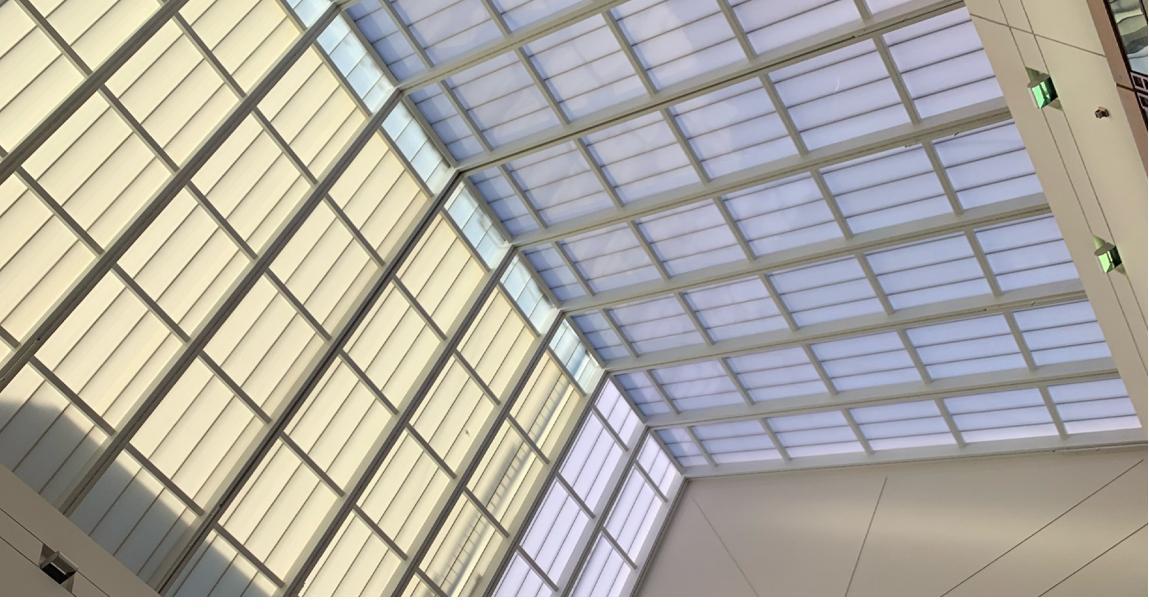
After storm damage, Brooks Army Medical Center's 25-year-old massive skylight was replaced. Picture of construction in progress shows new panels on the right and existing panels on the left.

The skylight in the lobby of the medical center was built 25 years ago. A 2019 summer storm rolled into San Antonio bringing high winds and hail. The wind caught the corner of the skylight at BAMC ripping some of the panels

off the building. Chamberlin was contacted to provide a temporary fix for the portions of the skylight where panels were missing. After all damages were assessed, a full replacement was recommended. Chamberlin was awarded the job to replace the skylight at BAMC under general contractor JG Contracting.

Crews removed a certain number of existing panels each night and installed permanent panels. Where permanent panels met existing panels, a temporary seal was used until additional permanent panels were installed during the next work shift. Communication and coordination were key elements of this plan.

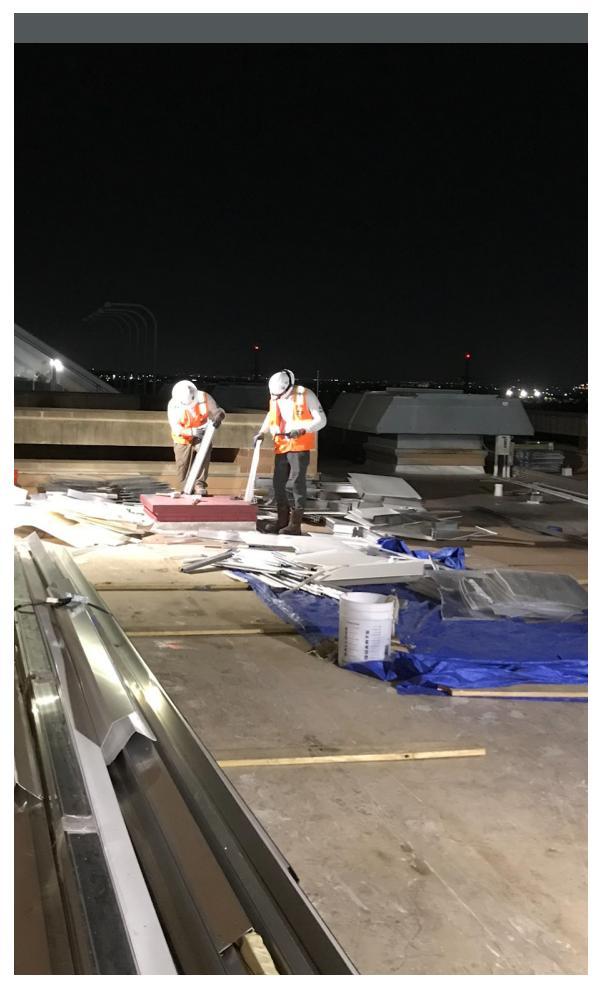
Chamberlin crew members worked nights for minimum disruption to the hospital lobby the skylight covered.

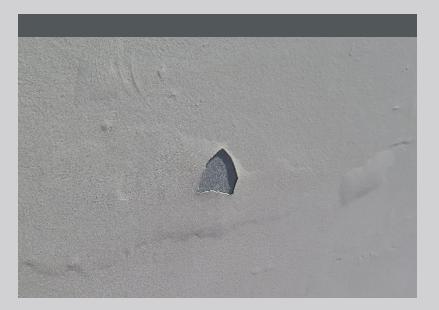
Photo 1: Bubbling behind the paint is a coating failure that could be avoided if proper tests are performed before job start.

Recently, I was involved in a case that exemplifies the necessity to pay attention to all of these materials. The work was done on several large warehouse buildings where the entire exterior was painted. The acrylic coating system, which comprised a primer and topcoat, was spray applied and back rolled. Within one year, the paint was spontaneously delaminating (Photo 1).

Adhesion tests were performed, and all patched areas, which were numerous, failed. In every instance, it was noted that some of the patching material stayed adhered to the rear of the delaminated paint while some remained on the wall. The client called me in to investigate this failure.

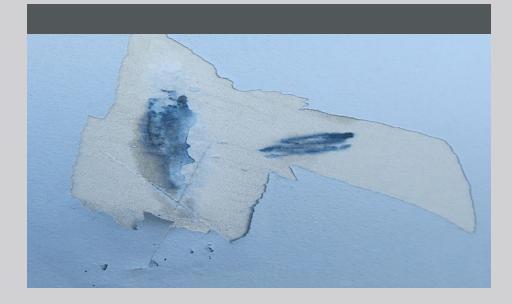
Photo 2: Coating application should not be installed until the surface pH is within the coating manufacturer's recommendations. This photo shows a highly alkaline substrate.

Coating application should not be initiated until the surface pH is within the manufacturer's recommended range for the specified coating system. If the pH is higher than 10, the concrete or patch may not be fully cured. High substrate pH can lead to paint failures such as alkali burn and saponification. Photo 2 shows a highly alkaline substrate in this particular case, which indicates that the patching compound had not completely cured.

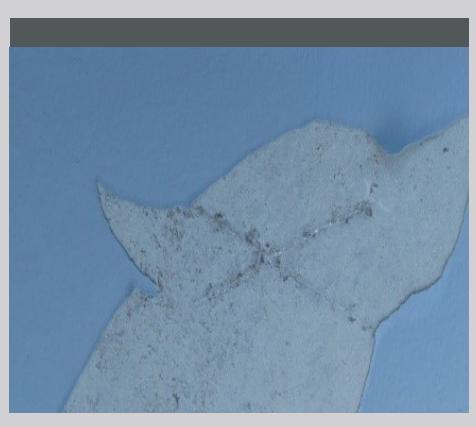
Photo 3: This photo shows the poor testing results obtained on the warehouse buildings.

In these cases, adhesion should be assessed per ASTM D6677, "Standard Test Method for Evaluating Adhesion by Knife." The first step of this test is to make two cuts into the coating down to the substrate. Using a sharp knife, the cuts should be made at a 30- to 45-degree angle between legs and should intersect to form an X. Using the point of the knife and beginning at the vertex of the angle, one should attempt to lift up the coating from the substrate or from the coating underneath. Photo 3 depicts a poor result of this test on the warehouse buildings.

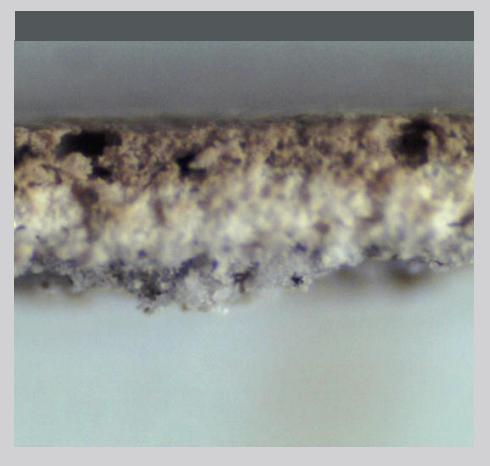
Photo 4: A photomicrograph of a cross-section of delaminated paint, showing a layer of patch attached to the rear of the primer.

The paint was delaminating because of a cohesion failure of the patching material, as seen in Photo 4. Cohesion is the force that holds a material together. In these instances, the patching material was friable, or crumbly. Unfortunately, there is no topical fix for this problem. Had this issue been discovered prior to application of the primer, then a special primer may have yielded satisfactory results. If poor adhesion is determined after the primer and paint are applied, then all patching and paint must be removed, a suitable high-strength patch applied where needed, and the paint system re-applied.

The delamination failures mentioned in this article could have been anticipated and even prevented had the painting contractor performed simple tests and prepared benchmark patch samples, prior to proceeding with the job, to assess the adhesion of the coatings. Taking a little time to perform these important tests on benchmark samples can save hundreds or thousands of hours redoing the job and a tremendous amount of aggravation for the painting contractor.
