# Protection From Above: ORU CityPlex Towers Roof Replacement

By: Richard J. "Jeff" Gish, P.E.  
Senior Associate, Terracon Consultants, Inc.

## Air Infiltration and Water Penetration Testing of Glazing Systems

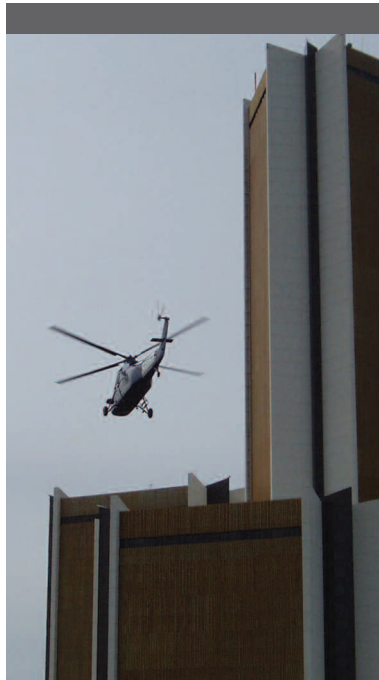
TPO roofing membrane delivered via helicopter

carrying materials through occupied offices up to the appropriate roof levels. After much consideration, Chamberlin instead chose to utilize a helicopter service to deliver materials to the roofs, which saved the team precious time on the project.

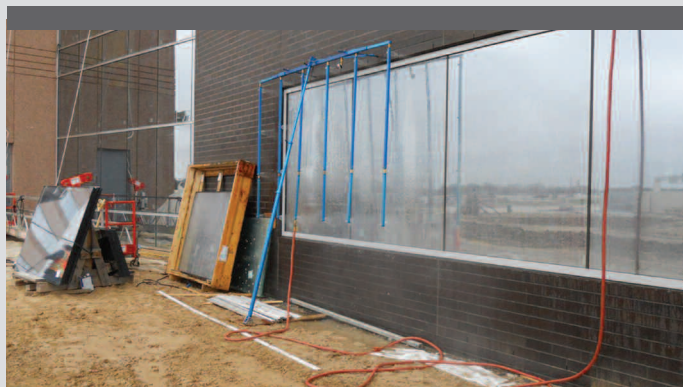
*Water penetration testing at a children's hospital annex.*

Water penetration testing is performed after the air test; in some cases air infiltration testing is not specified so the water test is the only test required. Pressure chambers are fitted to the interior or exterior face of the building envelope around the test specimen as opposed to being

fitted directly to the specimen in the air test. A water spray rack consisting of a grid of calibrated spray nozzles is fitted to the exterior of the test specimen to simulate a rain event. The consultant will create a negative static or cyclic pressure differential on the interior of the specimen and document any water penetration beyond the inside edge of the test specimen. If water penetrates beyond the innermost face of the test specimen, the specimen fails the test and corrective action is required.
