Effective Planning Sets Course for Successful Re-Roof at Houston's Intercontinental Airport

CONSULTANT'S CORNER:

Roof Uplift Testing: Know the Test Parameters and Use the Information Wisely

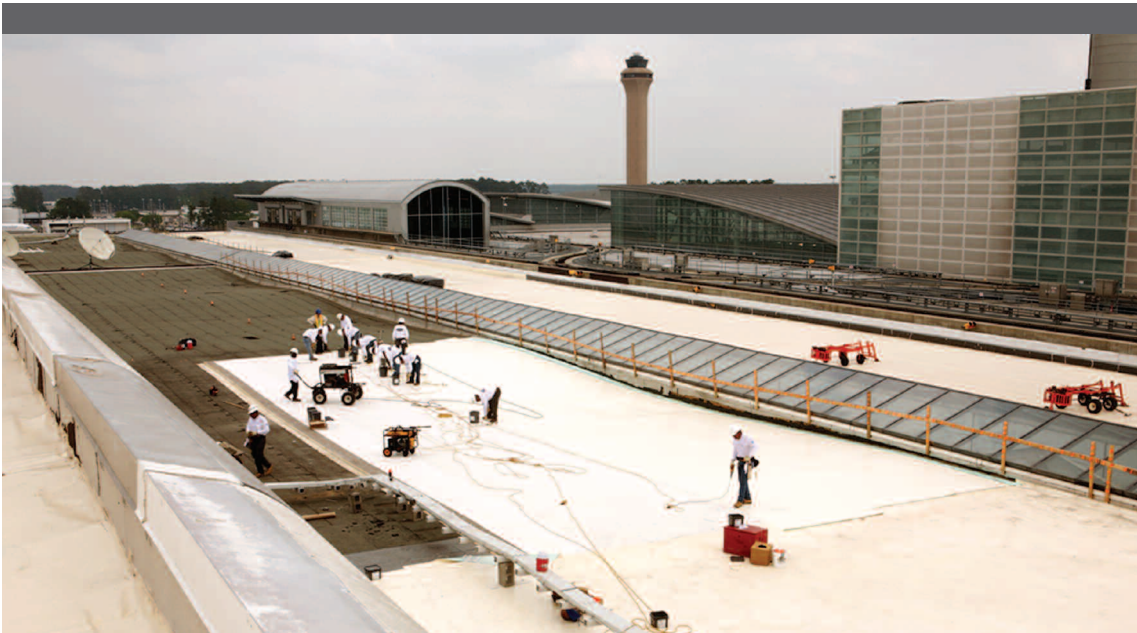
An expansive look at the 220,000 sq. ft. Terminal D re-roofing project in progress.

The scope of work included tearing off and removing the former roof system and installing a new Fibertite DuPont™ Elvaloy® KEE coated single-ply system along with associated sheet metal coping and counter flashing.

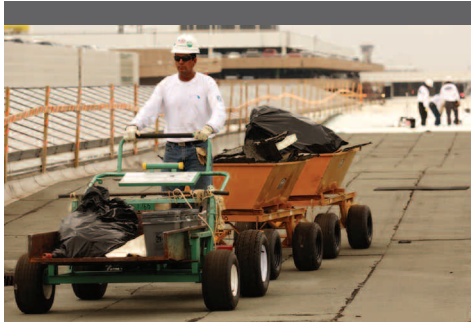
Fully loaded cart en route to garbage chute.

removal procedure and designed a chute engineered to meet the airport's safety protocols. First, Chamberlin built ramps over telecommunication systems, pipes and expansion joints in order to utilize motorized towing vehicles carrying debris

to the garbage chute. Behind the vehicle in a train car style were four-wheeled carts hauling the trash.

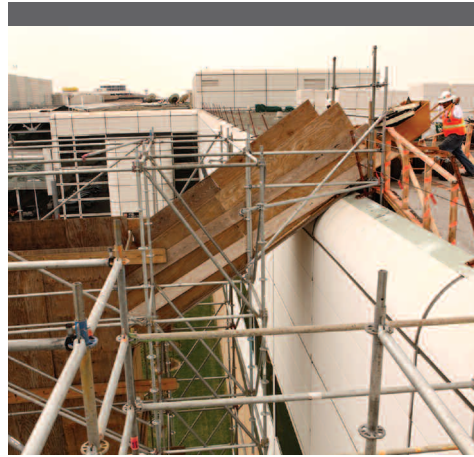
A 60 ft. tall, free standing garbage chute was engineered to handle 220,000 sq. ft. of demolished roofing material.

Second, a 60 ft. tall, free standing garbage chute was engineered to handle 220,000 sq. ft. of demolished roofing material. A special ramp was also created at the entrance to the chute so the motorized carts, which travelled in excess of one quarter of a mile, could pull up to the chute, dump the materials and go back for more. Additionally, a free standing stair tower was engineered and constructed adjacent to the garbage chute for worker access. Both structures were designed by Chamberlin to withstand hurricane force winds.

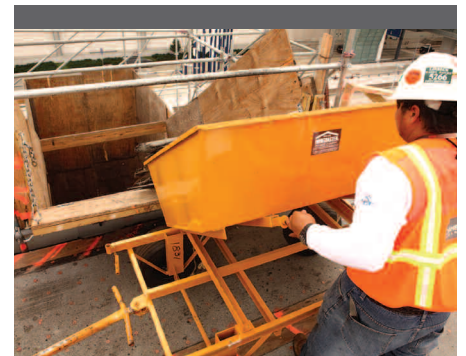
Chamberlin worker unloading debris into the garbage chute.

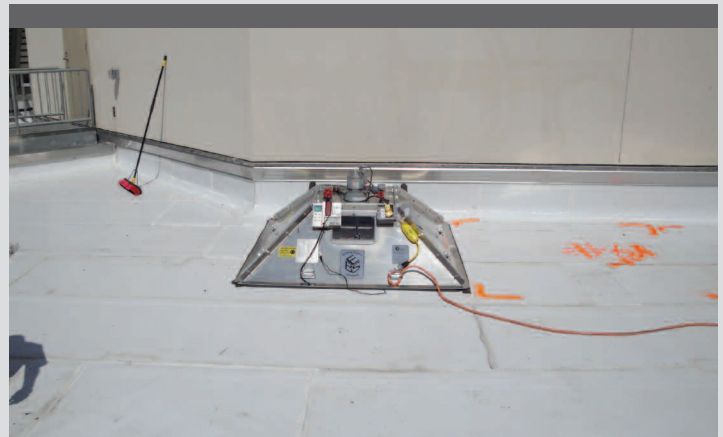
Negative pressure test or “bubble test.”

FM Loss Prevention Data Sheet 1-52 (FM 1-52), "Field Uplift Tests," provides for two methods of testing wind uplift resistance: the negative pressure test and the bonded uplift test. The negative pressure test utilizes a five foot by five foot dome that is placed over the roofing membrane surface. Negative pressure is then applied to the dome starting at an initial pressure of 15 pounds per square foot (psf). The pressure is increased in increments of 7.5 psf with each increment held for one minute until 1.5 times the design test pressure is reached or failure occurs. A deflection bar positioned in the center of the chamber measures upward deflection of the roof membrane. This test is sometimes referred to as the "bubble test." In years past, the test was often conducted using a durable skylight dome. In recent years, test pressures have been increased substantially requiring the use of negative pressure domes constructed of stronger materials.

The FM negative pressure test is based, at least partly, on the American Society for Testing and Material's (ASTM) E907, "Standard Test Method for Field Testing Uplift Resistance of Adhered Membrane Roofing Systems." The two tests are similar however, there are some significant differences. FM recommends that the chamber be placed "between roof supporting beams or joists (where practical), except when testing roofs on pre-cast concrete roof decks, in which case locate the test site over the joints in the pre-cast concrete deck." ASTM E907 does not include placement in their test discussion, but they do indicate that roof surface stiffness may be influenced by the roof deck and framing stiffness.

Another notable difference between the FM and ASTM uplift test is that the FM 1-52 test requirements for allowable deflection are more restrictive than ASTM E907. When using FM 1-52 test, the maximum allowable roof surface deflections are one quarter of an inch for pressures to 60 psf and one half of an inch for pressures between 60 psf and 120 psf. Whereas, when using ASTM E907, a one inch deflection is allowable at any test pressure.

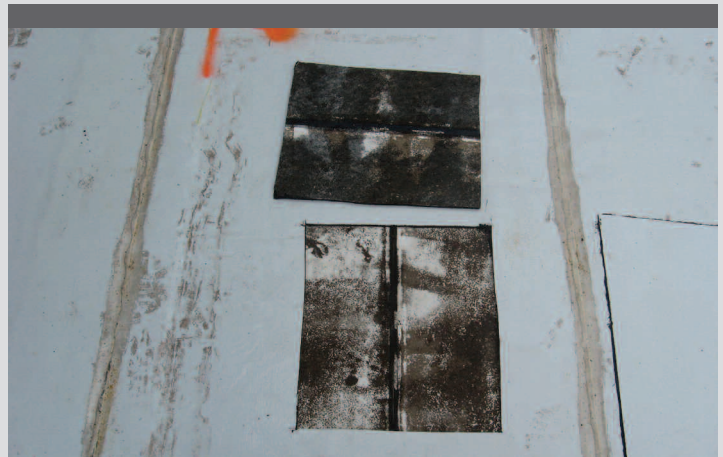
Inspection of the roof system after test failure.
