Chamberlin Chosen as the One Source for Building Envelope Restoration

The new metal standing seam roof of Great Hills Baptist Church in Austin, Texas.

Continuity of the Weathered Exterior Envelope — Can it be Realistically Achieved?

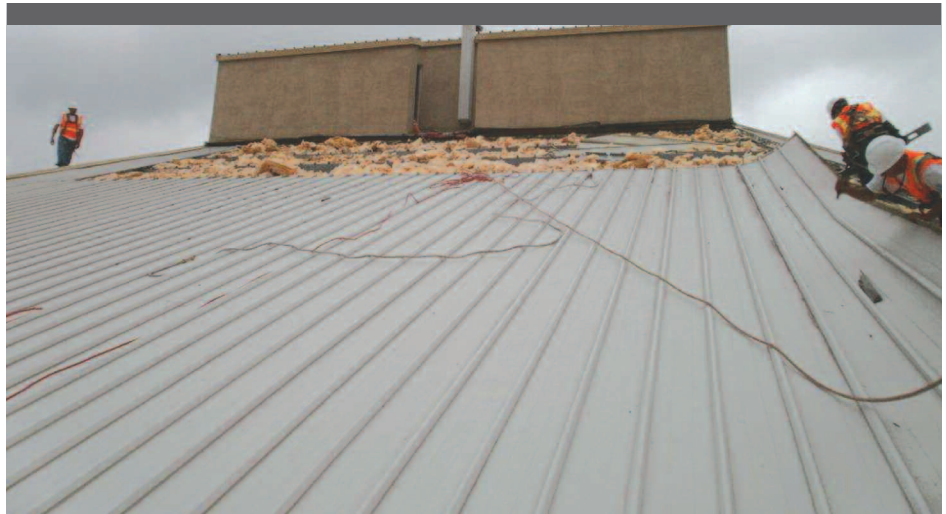
Chamberlin workers remove the old roof of the sanctuary in preparation for the new metal roof system.

Chamberlin removed the existing 50,000 sq. ft. metal roof over the sanctuary and replaced it with a new standing seam metal roof system and insulation all while keeping the church open for services. The roof is shaped like an uneven hexagon with a steep 6:12 pitch, so stringent safety precautions were instituted during the replacement process.

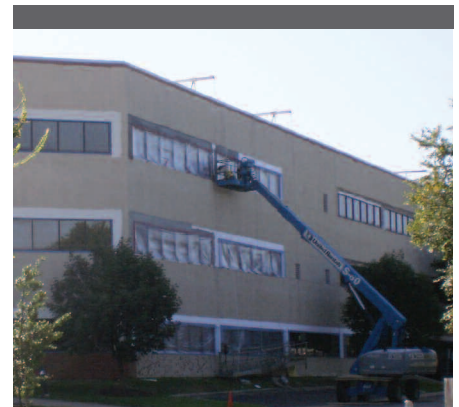
Chamberlin reflashed and recaulked windows.

While the new roof was being installed, Chamberlin waterproofers reflashed and recaulked windows then used an elastomeric coating to seal the whole facade. The new elastomeric coating changed the church from a beige to a brick red color, making it stand out a bit more in the neighborhood.

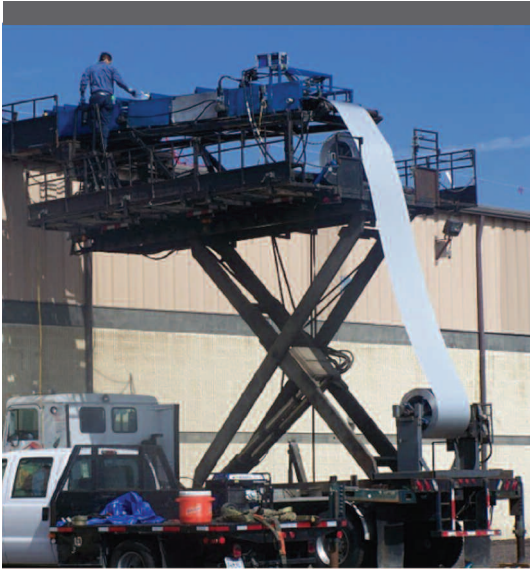
The Archzilla® sheet metal truck custom fabricated material on location.

Chamberlin utilized Architectural Building Components' Archzilla® job site production truck to custom fabricate the metal on location. This also allowed the Chamberlin team to take the panels directly from the truck to the roof for installation, making for a more productive project. Additionally, Chamberlin replaced the vertical metal wall panels that tie into the roof at the eaves and installed new vertical panels over a facade area surrounding the large cross at the peak of the roof.

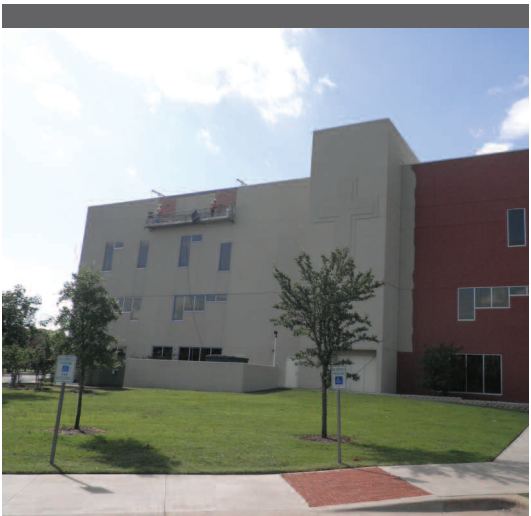
The new elastomeric coating being applied to the church facade.

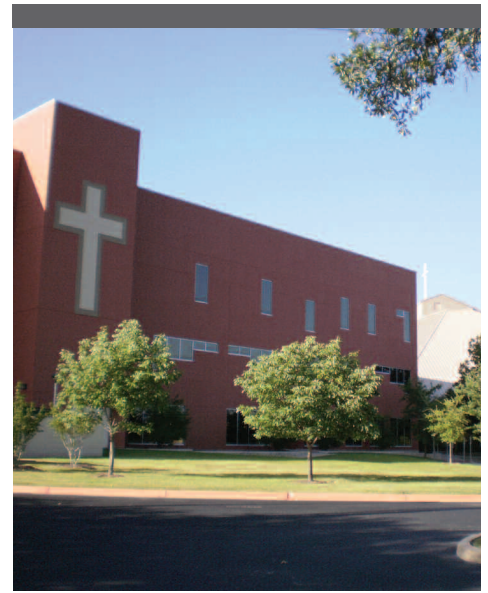
The completed project.

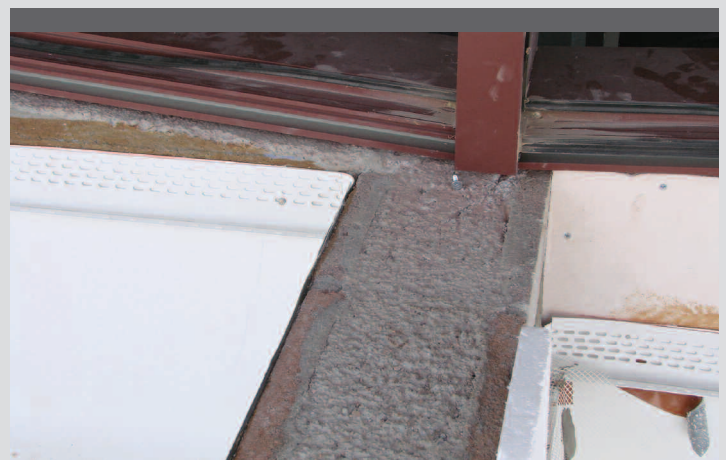
This lack of continuity between the sill of glazing, EIFS and roofing at parapet walls creates potential points of water infiltration.

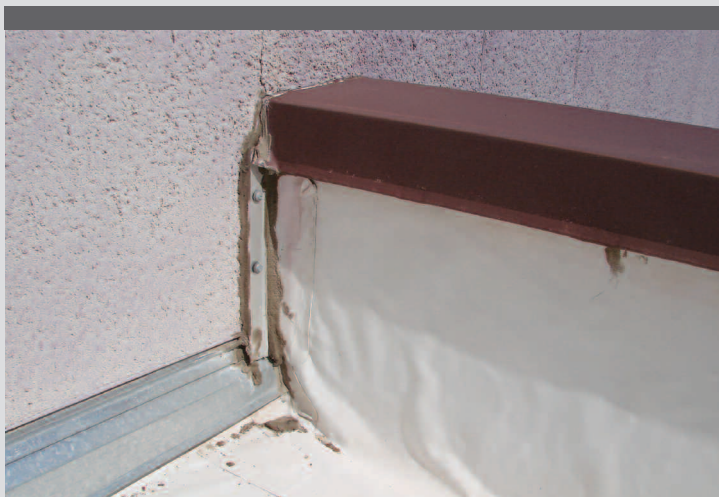
This photo shows no continuity between EIFS, roofing, flashing, and coping. EIFS should be flashed around parapet with an added weather seal and weep system.

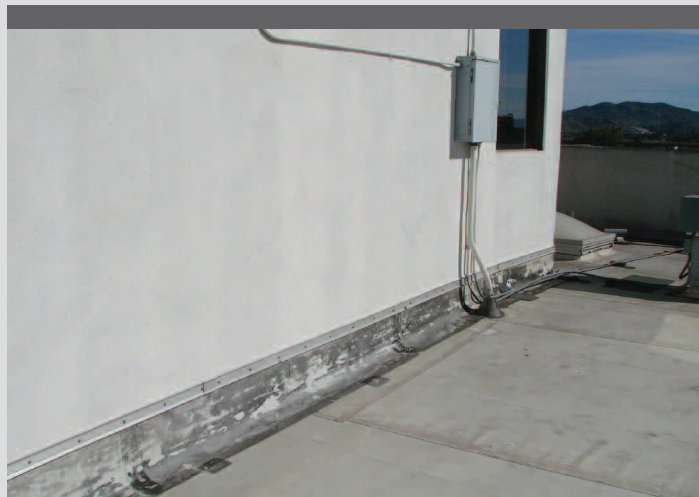
The roof membrane terminates to the face of the cement plaster without a weep screed at the plaster base. As installed, the plaster system will drain out underneath the roof system.
