21 Rio Gets a Face Lift

Chamberlin restored 21 Rio, a vibrant University of Texas at Austin student apartment complex.

Plaza Slab Systems Demand Proper Design

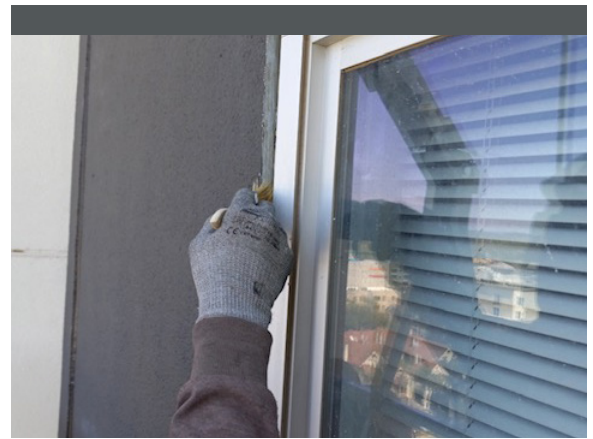
All windows and balcony doors were resealed.

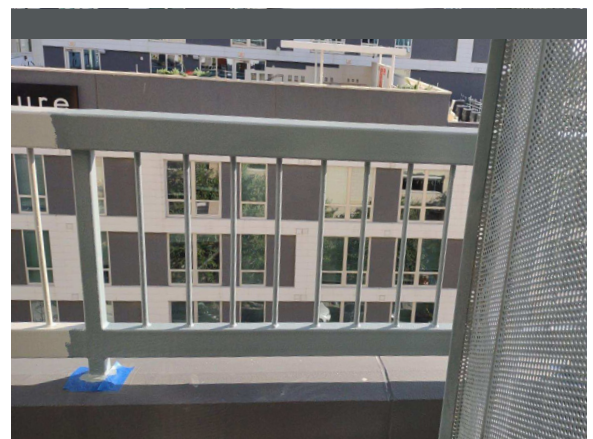
Balcony rails and coping were freshly painted.

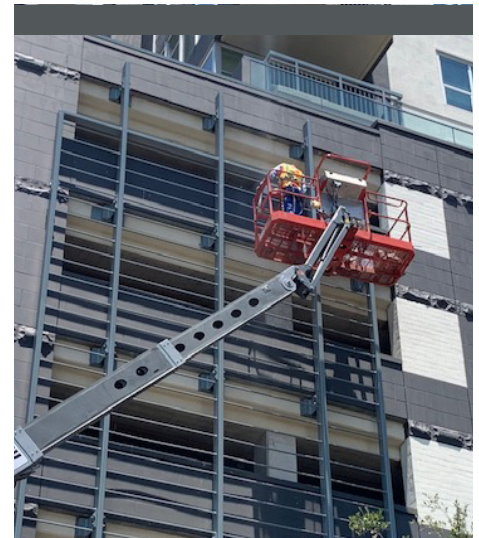
The lower portion of the building's elastomeric coating was performed from boom lifts.

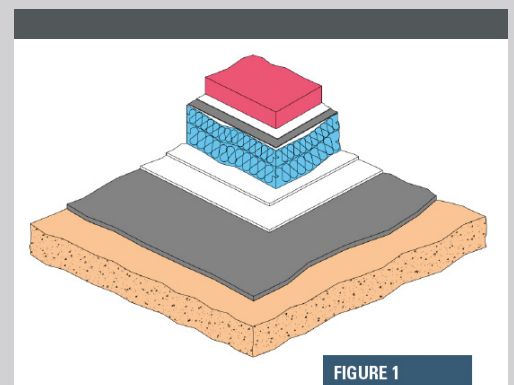
the building below. Plaza systems are sometimes referred to as sandwich slabs because of the layers of materials shown in Figure 1. The waterproofing (light grey), waterproofing accessories (white), and insulation (blue) are sandwiched between the structural slab below (dark grey) and the wear surface above (red). While the concrete and waterproofing options have not changed significantly since 2006, the increasing R-Values have resulted in increasing thickness of insulation. As the insulation has historically represented approximately 30% of the cost of a plaza system (excluding the structural slab), the 'meat' in this sandwich has gotten much more expensive.

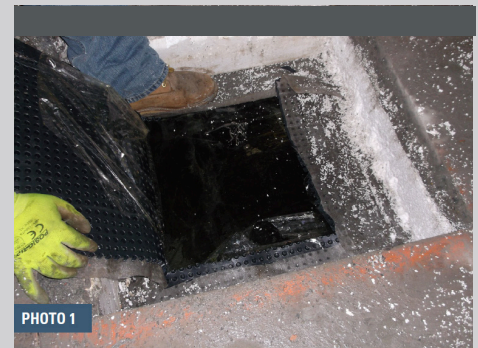
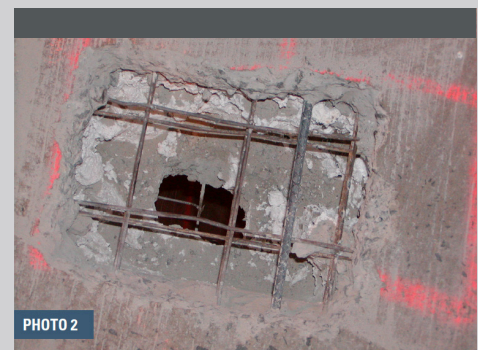
Test pits into existing plaza systems insulated with EPS 'bead board' insulation have shown favorable short-term (~two years) performance in colder climates, as seen in Photo 1. However, long-term (20+ years) exposure to freeze-thaw cycling has resulted in deterioration of the board into individual beads as seen in Photo 2.

Similar test pits were also conducted on plaza slabs insulated with XPS insulation. The short-term and long-term inspections of the insulation itself were both favorable, likely due to the physical characteristics of the board, as previously discussed and as illustrated in Photo 3. However, the success of the insulation board is sometimes accompanied by a failure in the wear slab. Because of the low absorption of the material, moisture remains on the insulation board, and freeze-thaw damage was observed

on the bottom of the concrete wear slab, as shown in Photo 4. This creates a new need to ensure drainage paths are designed to handle water at multiple layers of the plaza system.

This breakdown of the insulation as a cohesive material causes the loss of its insulating and compressive strength characteristics. In most cases, this leads to cracking of the wear slab, damage to the waterproofing membrane, and even condensation on the underside of the structural slab below, prompting replacement of the entire plaza system.
