#### Assessing the Existing Roof

CHAMBERLIN  
Roofing & Waterproofing

NEWSLETTER

## Houston House Exterior Renovation

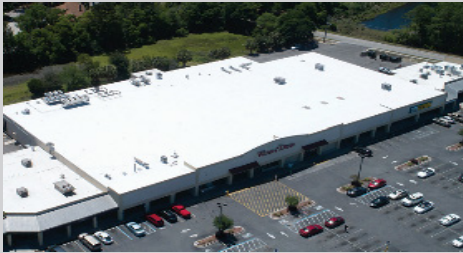
Photo 2: This photo shows a building's roof post roof restoration.

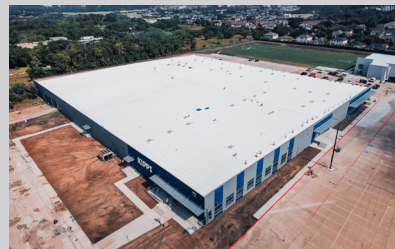
Photo 1: This photo shows a roof that was freshly re-coated.
