Chamberlin Waterproofs The Star

The Ford Center at The Star, Frisco, Texas

Improving Energy Performance in Existing Buildings

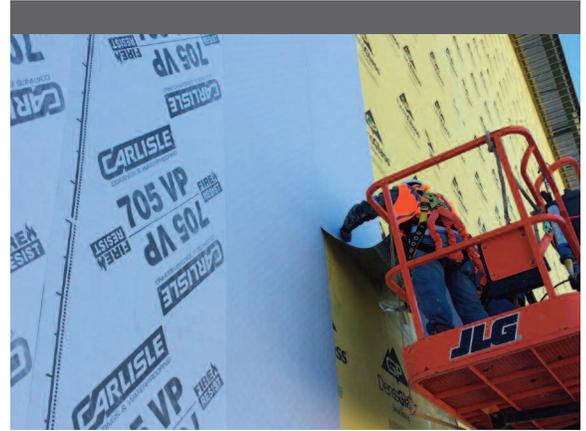
Applying “peel and stick” waterproofing to the north wall of The Ford Center.

During the preconstruction process, Chamberlin noticed a tie-in concern between the below-grade waterproofing system on The Ford Center’s parking garage and the hot fluid-applied waterproofing that was to be applied to the horizontal slab on the plaza above. The below-grade waterproofing to be installed was a “peel and stick” material made of raw asphalt covered with a plastic facing, to which the hot-applied waterproofing would not adhere. Over time it would become brittle and break away, disconnecting the two waterproofing systems and allowing water to infiltrate the parking garage.

Upon discovering that no pre-existing detail would resolve this problem, Chamberlin suggested a new detail. To begin, an additional, sacrificial layer of the peel and stick was applied where the systems met. The plastic facing on the top of the additional layer was then removed using a roofing torch, revealing the raw asphalt portion of the peel and stick waterproofing system. Since the hot fluid-applied waterproofing system is also asphalt-based, they were then able to adhere together completely. Meanwhile, the bottom half of the additional piece of peel and stick would continue to adhere to the existing peel and stick waterproofing installed on the vertical

wall. The two systems were successfully tied together with a full, single layer of peel and stick membrane left undamaged.

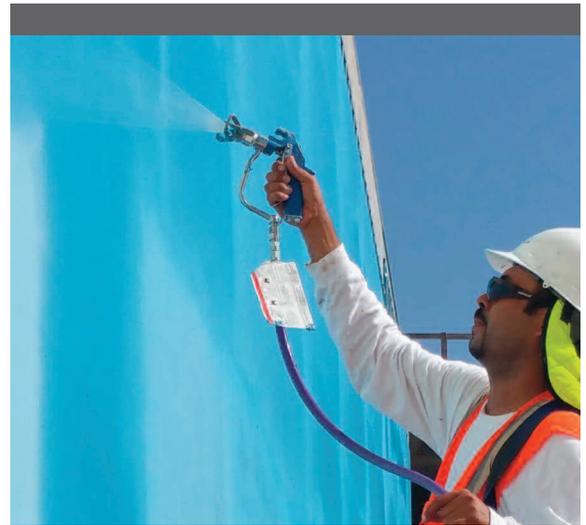
Installing spray-applied air barrier to the exterior wall of The Ford Center.

indoor athletic facility containing the Dallas Cowboys indoor practice field, training room, office space and hydrotherapy. Chamberlin worked on both facilities and their parking garages installing approximately 320,000 square feet of spray-applied air barrier, 215,000 square feet of hot fluid-applied waterproofing, 200,000 linear feet of sealants and 125,000 square feet of sealer. Chamberlin’s scope also included firestopping, water repellents, sheet metal flashing and trim, pavers and expansion joints. This massive scope was completed in 16 months with a total contract amount of nearly \$5,000,000.

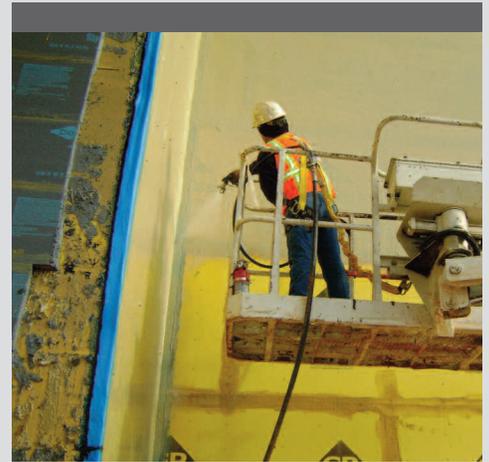
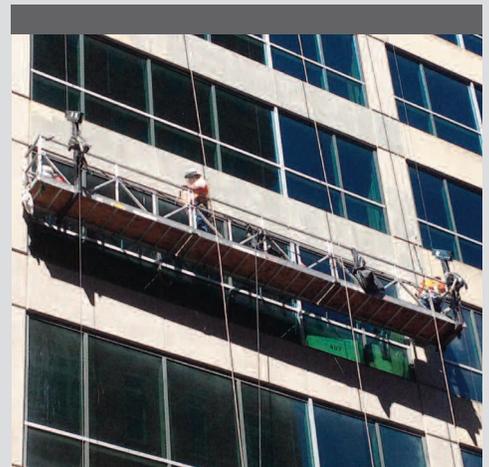
Similar to case study #1, we developed a whole-building energy model to perform an energy demand analysis. The analysis showed a comparison of the existing

whole-building energy performance versus change in heating and cooling demands for various building enclosure upgrade options. The various upgrade options included full replacement of window systems, adding insulation to the interior side of opaque wall assemblies, adding roofing insulation by roof replacement or to the underside of the roof deck and a combination of each.

A university client approached us regarding a large, 10-story, over 300,000-square-foot facility that was experiencing high energy use and widespread water leakage in the exterior walls. The existing facility was constructed of cast-in-place concrete with thousands of window openings with translucent panels and less than 10% IGUs (the remainder being monolithic glazing). Many windows were experiencing deteriorating window films and approximately 75% experienced water leakage problems.
