## NEW ROOF FOR FORTUNE 500

Chamberlin Roofing & Waterproofing installed a fully tapered PVC roofing system for Charles Schwab's new headquarters in Westlake, Texas. The 1.1 million-square-foot campus is spread across 70 acres within Hillwood's Circle T Ranch development. Designed by Corgan, it was built in two phases with the second finishing mid-2021.

### Reimagining the Plaza: Balancing Past and Present in Rehabilitation

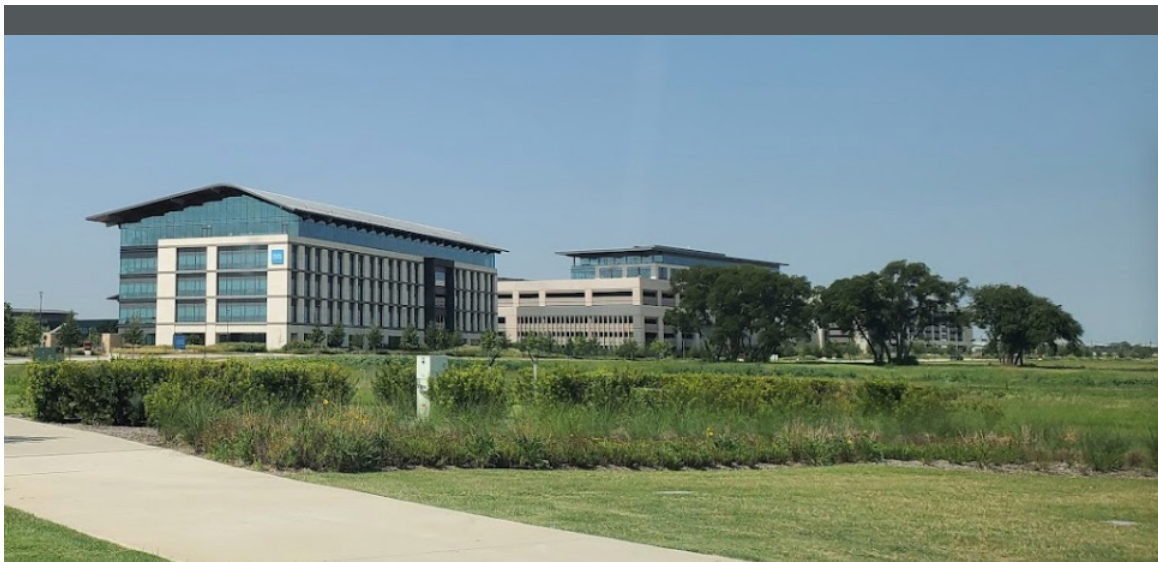
*Charles Schwab's new headquarters in Westlake, Texas.*

The install began with two layers of adhered insulation followed by a full quarter inch per foot of adhered tapered insulation. Then, one layer of adhered DensDeck cover board was capped with adhered Sikaplan PVC membrane.

A concrete deck was the main substrate for the roof. Surrounding this was a metal deck overhang referred to as an outrigger deck. In between the

metal and concrete decks was simply framing, leaving a gap for water to enter the building. None of the drawings or specifications clarified why the space was open or how to address water infiltration. Chamberlin met the challenge with some creative problem solving. First, the framing was boarded with plywood. Sika membrane was then installed on the plywood to prevent water intrusion.

The second part of the challenge was installing the insulation to seamlessly transition from the concrete deck to the metal deck. This took extra layers – up to 20 inches in some areas – and precise work with the tapering. For accurate installations one time, the first time, crew members started by loose laying the insulation boards to test the configuration before adhering to the substrate.

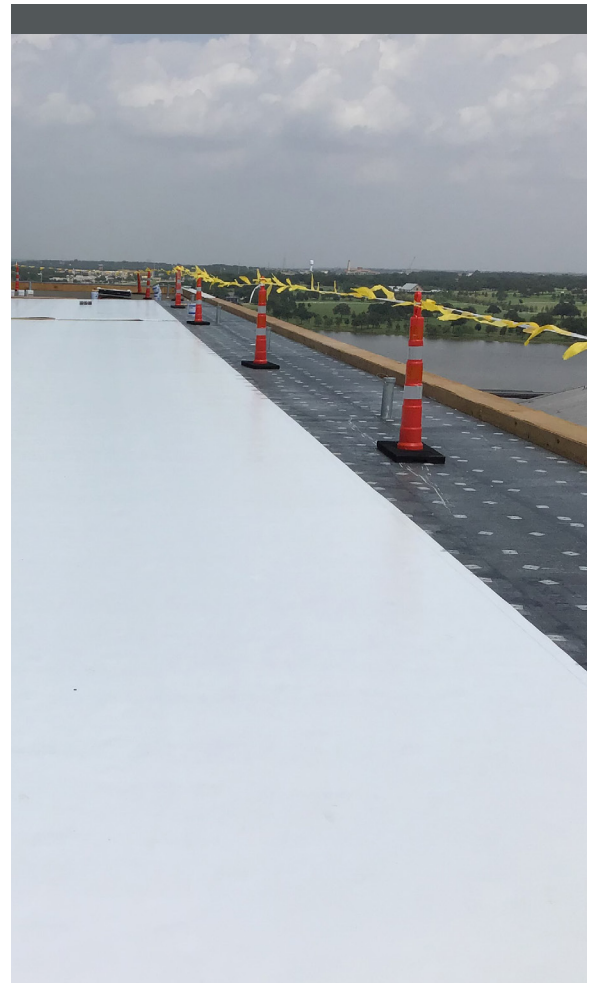
PVC roofing system installation in progress

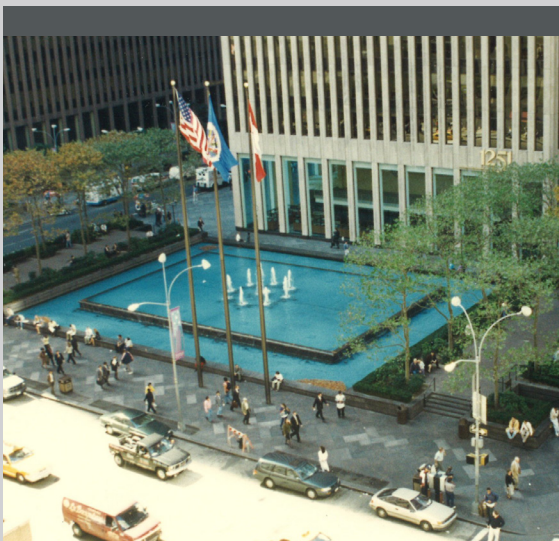
Photo 1: The horizontality typical of mid-20th century modernist plazas is expressed as a water feature at 1251 Avenue of the Americas, New York.

Plazas that support skyscrapers—such as the Seagram Building, One Chase Manhattan Plaza and 1251 Avenue of the Americas in Manhattan (see Photo 1)—are typified by wide expanses that serve as a platform for these modern structures. How this was accomplished varied. The Seagram Building (see Photo 2) and One Chase Manhattan plazas are fields of granite while 1251

Avenue of the Americas uses a large pool and fountain on its major elevation to establish the horizontality that dominates the style.

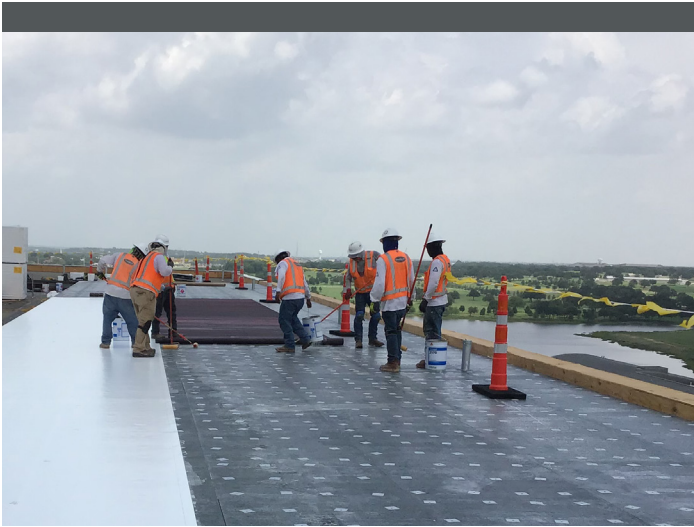
*Chamberlin crew members installing membrane over cover board*

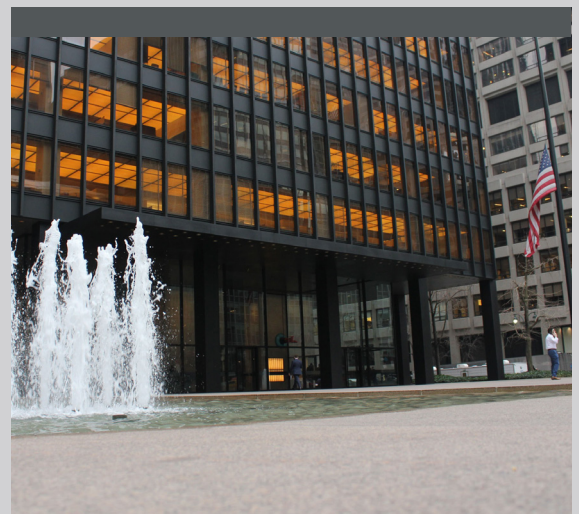
*Photo 2: New York's Seagram Building at 375 Park Avenue is a leading example of the use of wide expanses of hardscape as a platform for a modern structure. It is typical of modernist plazas in the mid-20th century.*

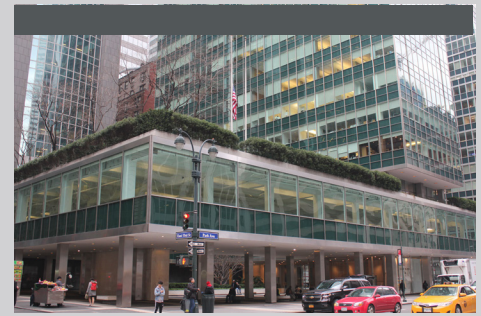
Photo 3: A modernist hardscape is internalized and removed from the street plane at Lever House, 390 Park Avenue, New York.
