Four-Year Roofing Project Touches Down in Dallas

Elastomeric Restoration Systems: A Viable Alternative to Roof Tear-Offs

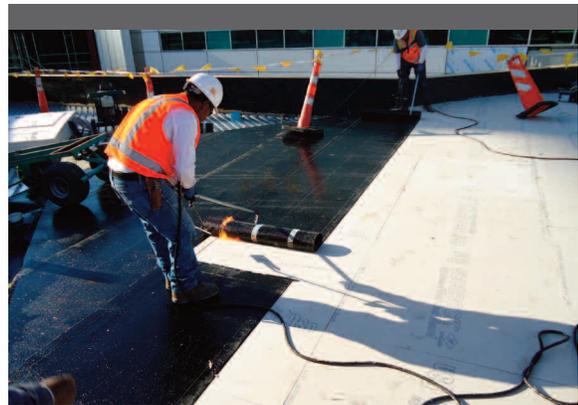
Chamberlin installed over 10 acres of Soprema's torch-applied roofing system on the terminal.

Chamberlin Roofing & Waterproofing was selected by General Contractor Hensel Phelps as the roofing contractor for this project. Chamberlin re-roofed the existing main terminal and installed a new roofing system on the expansion of the main terminal, new baggage claim, ticketing wing and concourses. In total, 450,000 square feet of a torch-applied Soprema two-ply modified bitumen roofing system was installed.

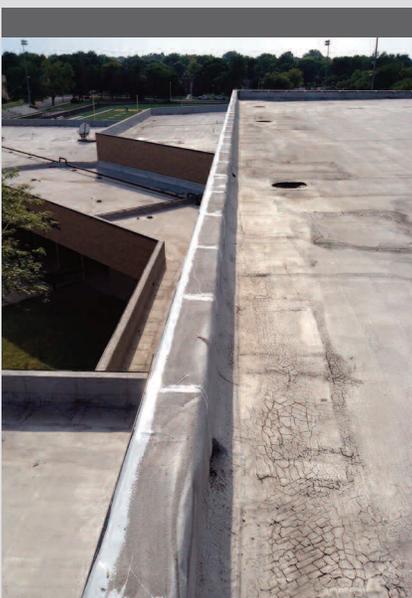
Kansas school district aging roof before restorative elastomeric coating was applied.

Project Overview: A school district in central Kansas was starting to have some aging issues with their asphalt roofs. In some areas, the cap sheet was “bubbling” and “delaminating,” in other places the seams were failing, and in yet others the parapet walls and penetrations needed to be re-flashed. The District was looking for the most cost effective option while still hoping to get a viable 10-year warranted system for the building. The School District was not aware of white reflective roof coatings as an option for their aging roof. Throughout the years many contractors

Substrate Preparation: Most elastomeric coating system guidelines require a properly prepared substrate before the application of the coating restoration system. For this particular system, there were some concerns that needed to be addressed. First, there were numerous delamination bubbles in the granular modified bitumen cap sheet. These needed to be cut out and repaired with similar materials. Second, there were a number of hail-damaged areas that were sealed. Third, all minor deck repairs were made and flashed-in with repair sealant.

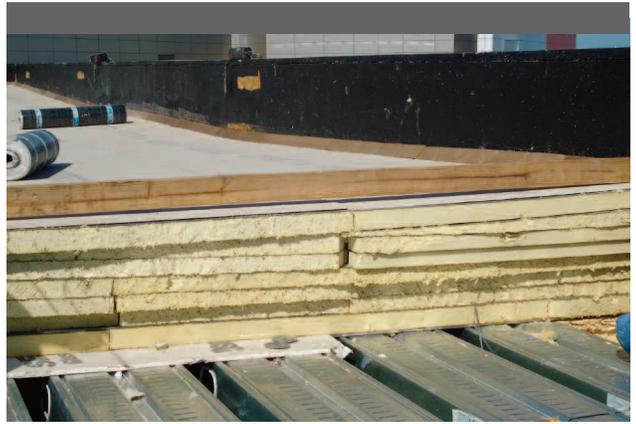
Chamberlin redesigned the roofing system to allow for proper drainage, adding as much as six inches of extra insulation to meet required slope.

While installing the new roof system on the baggage claim facility, Chamberlin discovered an oversight in the construction of the building. The roof deck was not properly sloped for drainage. Instead, it was mostly flat in areas where it should be

slanted to allow the water runoff to reach the drains. The result of some sloping and some flat areas created a wavy effect across the rooftop. One light rain immediately after this discovery confirmed that pooling water would be a huge issue on this roof. Chamberlin redesigned the roof installation on the spot to solve the issue without replacing the roof deck. After conferring with Hensel Phelps on the plan, they got started rectifying the situation.

To begin, the previously installed insulation was removed. Then Chamberlin began re-installing the insulation, adding extra to fill in the flat areas and raise them to meet the necessary slope of the roof. Some areas required up to six inches of additional insulation. Once the roof was leveled at the appropriate slope, Chamberlin proceeded with installing the two-ply Soprema modified bitumen roofing system. The finished product resulted in a roof that efficiently and effectively drains water. This was all done without interrupting the overall production schedule of the project.

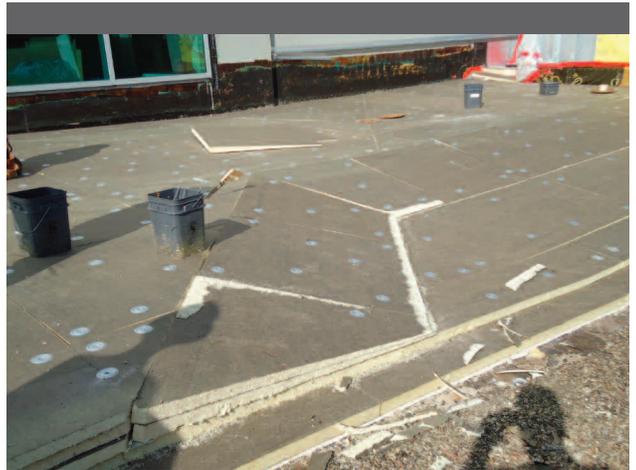
Insulation was added to the roof area and tapered toward drains.

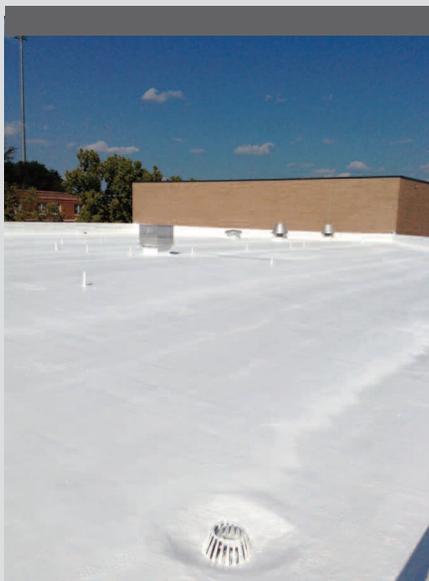
Kansas school district roof after restorative coating is installed.

Coating System Installation: Once the asphalt BUR was properly prepared, a bleed blocking basecoat was applied at a rate of 1.5 gallons per 100 square feet in one application pass.

After the basecoat cured, all-purpose urethane hybrid repair sealant was applied to all flashings and penetrations, as well as the asphalt terminations on top of the parapet walls. Once all sealant was applied, a high tensile acrylic coating was applied at a rate of 1.5 gallons per 100 square feet in one pass. The high tensile acrylic coating was chosen as the topcoat because of its ability to stay whiter longer than traditional acrylic coatings. It also has very strong tensile strength properties, which in turn help with foot traffic durability on the roof. And lastly, the high tensile finish coat has a glossy sheen to it which makes it a much brighter and aesthetically pleasing look.

150 to 165 degrees Fahrenheit range before the system was applied. After the system was installed, the substrate temperature was 90 to 100 during the hottest time of the day. This drop in thermal shock on the roofing system will significantly extend the life of the roofing system.

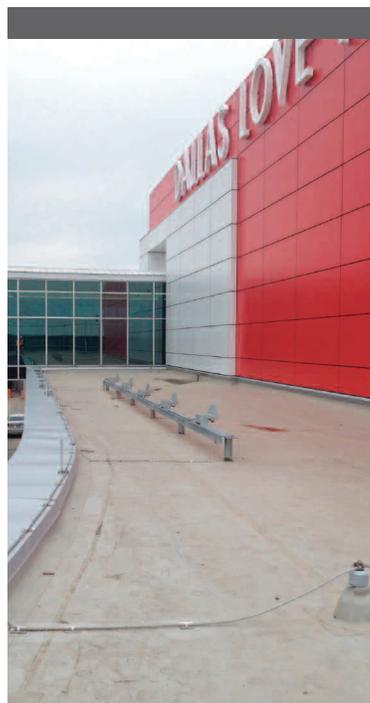
The finished GAF Roof at Dallas Love Field entryway.

Chamberlin also installed a 45,000 square-foot GAF PVC roof on the main canopy at the airport entrance as well as a 40,000 square-foot Firestone TPO roof system on a roadway canopy. Chamberlin's scope of work also included the installation of 12,000 lineal feet of Hickman aluminum coping on all of the roofs combined. A 10-man crew worked for four years to complete this tremendous project on time and with no safety incidents.
