SPRING 2023

CHAMBERLIN
Roofing & Waterproofing

NEWSLETTER

Even Smart Roof Coatings Can Fail

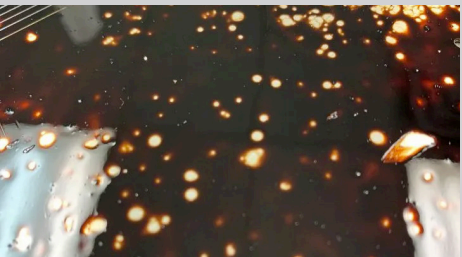
Photo 2: This photo shows cissing and dimpling, also known as fish eyes. This is caused by surface defects.

Cissing and dimpling – also known as fisheyes – are similar to cratering, but the primary difference is what is causing the defect. Where bubbles or bubble remnants are the cause of cratering, surface defects cause cissing and dimpling. Cissing occurs when the coating exposes a small spot of the substrate, usually around 1-43 mm (0.4-0.12 inch) in diameter. Dimpling looks like cissing, but the substrate has not been exposed. The defects are observed easier over smooth surfaces, such as metal or single-ply roofs where residual processing oils or engrained greases near vent pipes could interfere with the coating wet out.

Cissing & Dimpling Can Include:

- Surface contaminants
- Unauthorized thinning and incompatible thinners.

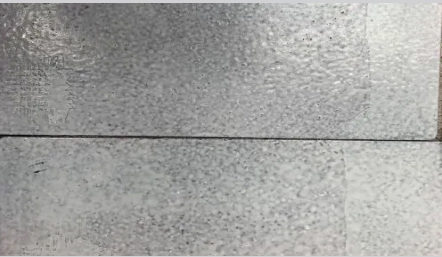
Photo 3: This photo shows grinning; another potential roof coating system failure.

Grinning is related to the coating's opacity and describes the inability of the top coating to properly hide the previous coat or the original surface.

When the coating is applied too thinly, it does not reach its full strength and creates a weak spot in that area, a likely candidate for future issues such as tearing. Follow the manufacturer's application rate. There are some coatings that are formulated to cure or dry better at thin applications versus thick applications, and depending on the formula, those thin applications can be recoated in the same day.

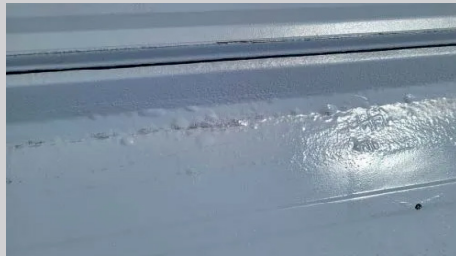
Photo 4: This photo shows blistering, which occurs when there is pressure under the coating.

Blistering and bubbling are often confused for the same thing. In reality, a bubble is a type of blistering caused by a specific phenomenon, whereas a blister can form from multiple mechanisms. The primary force involved with blistering is pressure from moisture exerted through the coating, typically referred to as osmotic pressure.

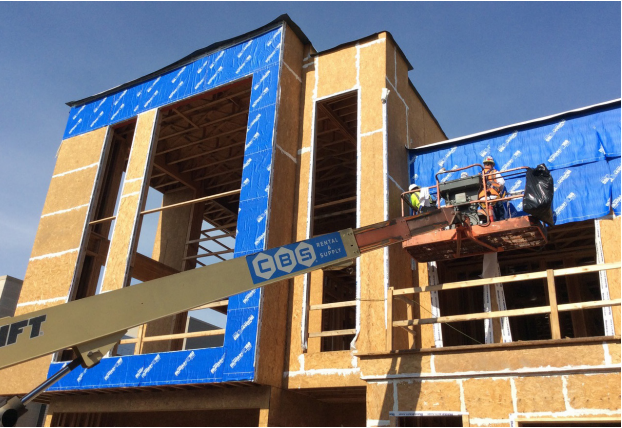
Chamberlin crew working on a weather barrier installation.

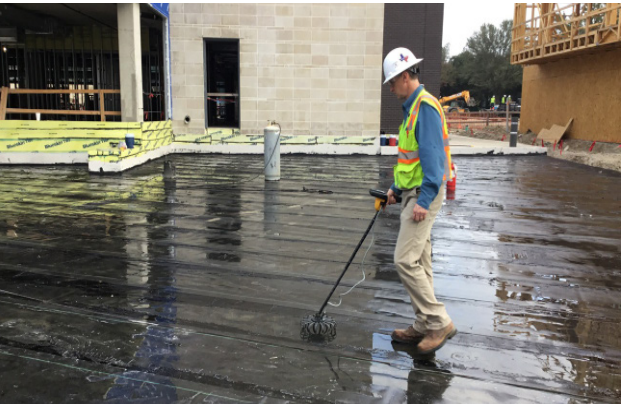
Chamberlin using electric field vector mapping, to help check for waterproofing membrane for breaches.

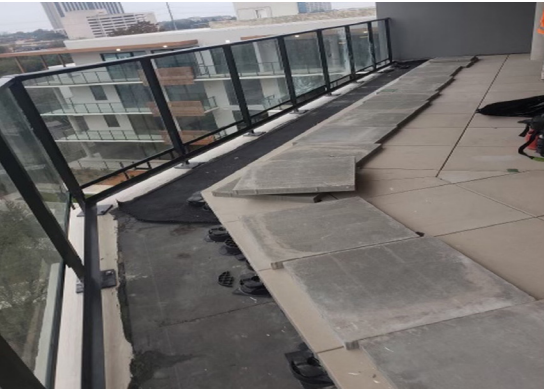
This image was taken during the installation of the Wausau pedestal pavers.

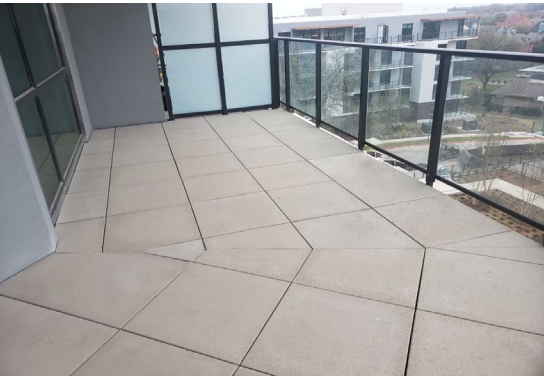
This image was taken after Chamberlin was finished installing the Wausau pedestal pavers.

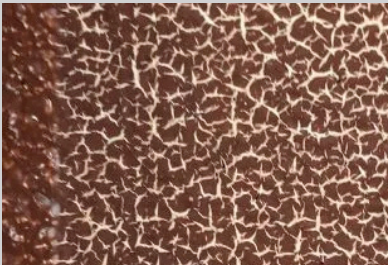
Photo 1: This photo shows mud cracking, which may be caused by a variety of issues related to stress.

Mud-cracking, or just cracking, is a stress-related failure.

Just as not applying enough coating causes issues (see grinning), so, too, does applying too much coating at once. Again, read the provided manufacturer's application rate. While the manufacturer's representative should be able to help you choose the right roof coating for the application, the more information that you or the customer can provide about the system being installed and the condition of the roof will help ensure the proper choice is made.
