SPRING 2026 NEWSLETTER

Turkey Bend - Buffalo Bayou

Turkey Bend Warehouse - Buffalo Bayou (pg. 1-3)

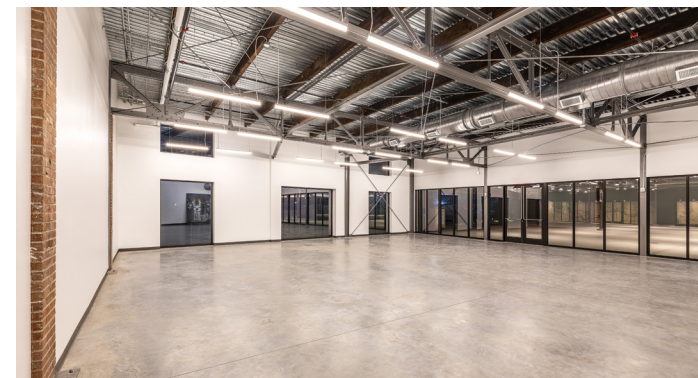
We also installed areas of new metal decking and reused portions of the original wooden decking to maintain a consistent appearance of overhead structure while ensuring the safety of pedestrians and visitors of Turkey Bend. After the deck was installed, a new TPO roof was installed. All details around penetrations,

curbs, and wall terminations were flashed to ensure a watertight transition, and edge metal, mechanical curbs, and penetrations will be completed with appropriate sealants and trim. Temporary protection and walkways were provided during installation, and quality control included seam testing, water testing, and warranty documentation. A critical factor in TPO success is maintaining proper temperatures during seaming and ensuring the substrate is flat and free of damage to prevent ponding or membrane failure.

The work began with mobilization and site preparation, followed by salvage of the existing wood deck and demolition of the existing gypsum deck. Next, we performed purlin repair that involved a thorough assessment of all existing wood purlins supporting the roof deck. It was crucial that our team upheld safety standards when determining whether or not the purlins were salvageable. The purlins that we deemed too compromised were sistered or replaced with new wood purlins.

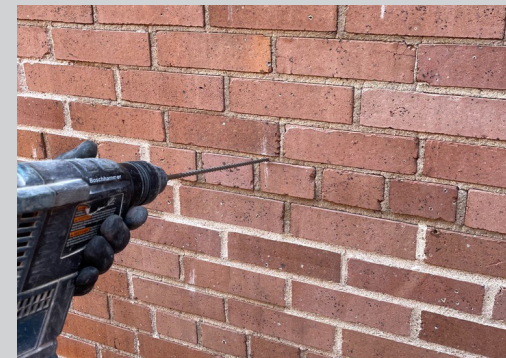
STEP 1: Drill a pilot hole using a percussion hammer drill through the mortar joint.

Are you in need of reattaching the existing masonry veneer to your commercial building's main structure? This process avoids the costly and disruptive need to remove and replace the entire facade, helping to keep the building's appearance and historical look intact.

At Chamberlin Roofing & Waterproofing, we don't cut corners. When it comes to sealing, shielding, and standing the test of time, durability matters to us. A solution we can use is called Helical Stitch Ties. These re-anchor the veneer to the structure of your building.

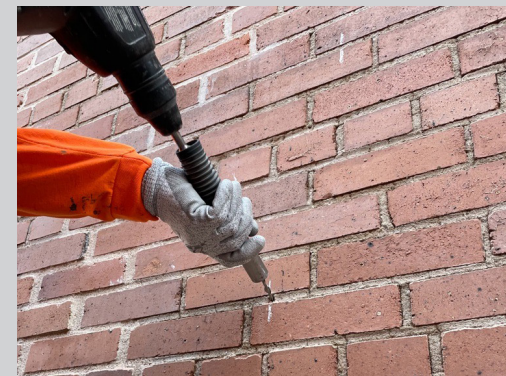
STEP 2: Insert the Stitch-Tie into the dry set installation tool mounted on the rotary hammer S.D.S. drill.

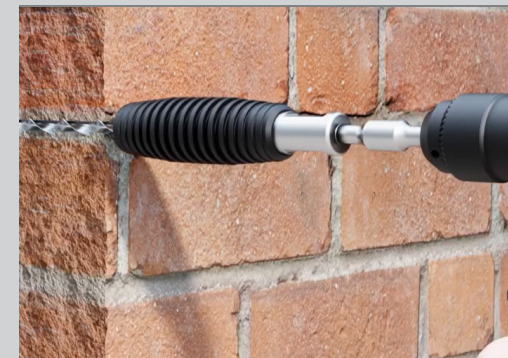
STEP 3: Drive the Stitch-Tie until the nose of the dry set installation tool is hard against the veneer.

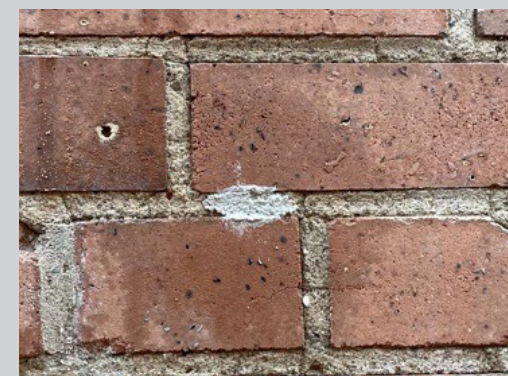
STEP 4: The dry set installation tool automatically recesses the Stitch-Tie into the face of the masonry to patch the hole.
