FALL 2022 Beneficial Chamber Line Roofing & Waterproofing

21-Story Luxury Sky Tower Hotel Revitalization

Failures of Improper Use of High-Voltage Holiday Detectors

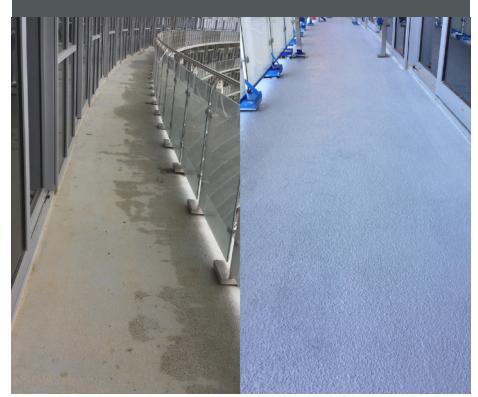
Chamberlin installed traffic coating to aid in protecting against damage or deterioration.

In addition to that, swing stage scaffolding was used during most of the caulking process. It was also used during traffic coating on concrete bands that were approximately three feet wide on multiple floors.

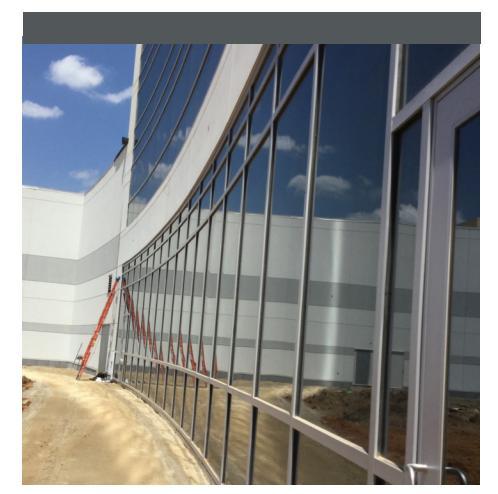
Most of the project consisted of EIFS caulking.

Tutor Perini Building Corporation. Tutor Perini chose Chamberlin as they were the only subcontractor that passed the third-party performance testing on the Exterior Insulation and Finish System (EIFS) caulking, which is what most of the project consisted of. The other subcontractors tried two to three times and could not achieve a successful passing result like Chamberlin did.

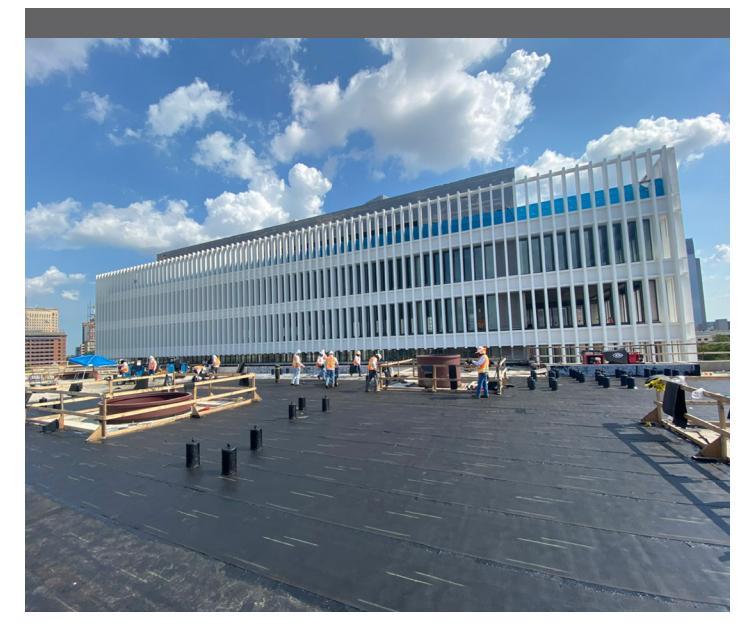
Due to Chamberlin's expertise, Post Houston is fully watertight.

The hot-applied waterproofing had to be protected with plywood and insulation at most areas since different trades were working on top of the installation. Added penetrations such as piping, conduit and fasteners in areas where the waterproofing system was complete was a constant challenge as the crew had to make sure the system was not compromised as unsealed penetrations lead to leaks. Another large portion of the scope was the polyurethane grout curtain injection in the tunnel. Due to Chamberlin's expertise, Post Houston is fully watertight.
